**The Republic of the Union of Myanmar**  
**Ministry of Transport**  
**Department of Meteorology and Hydrology**  
**Review of the Hydrological Impacts of Myanmar**  
**in 2010 and 2011**

## *Causes of Shwechaung Flash Flood*

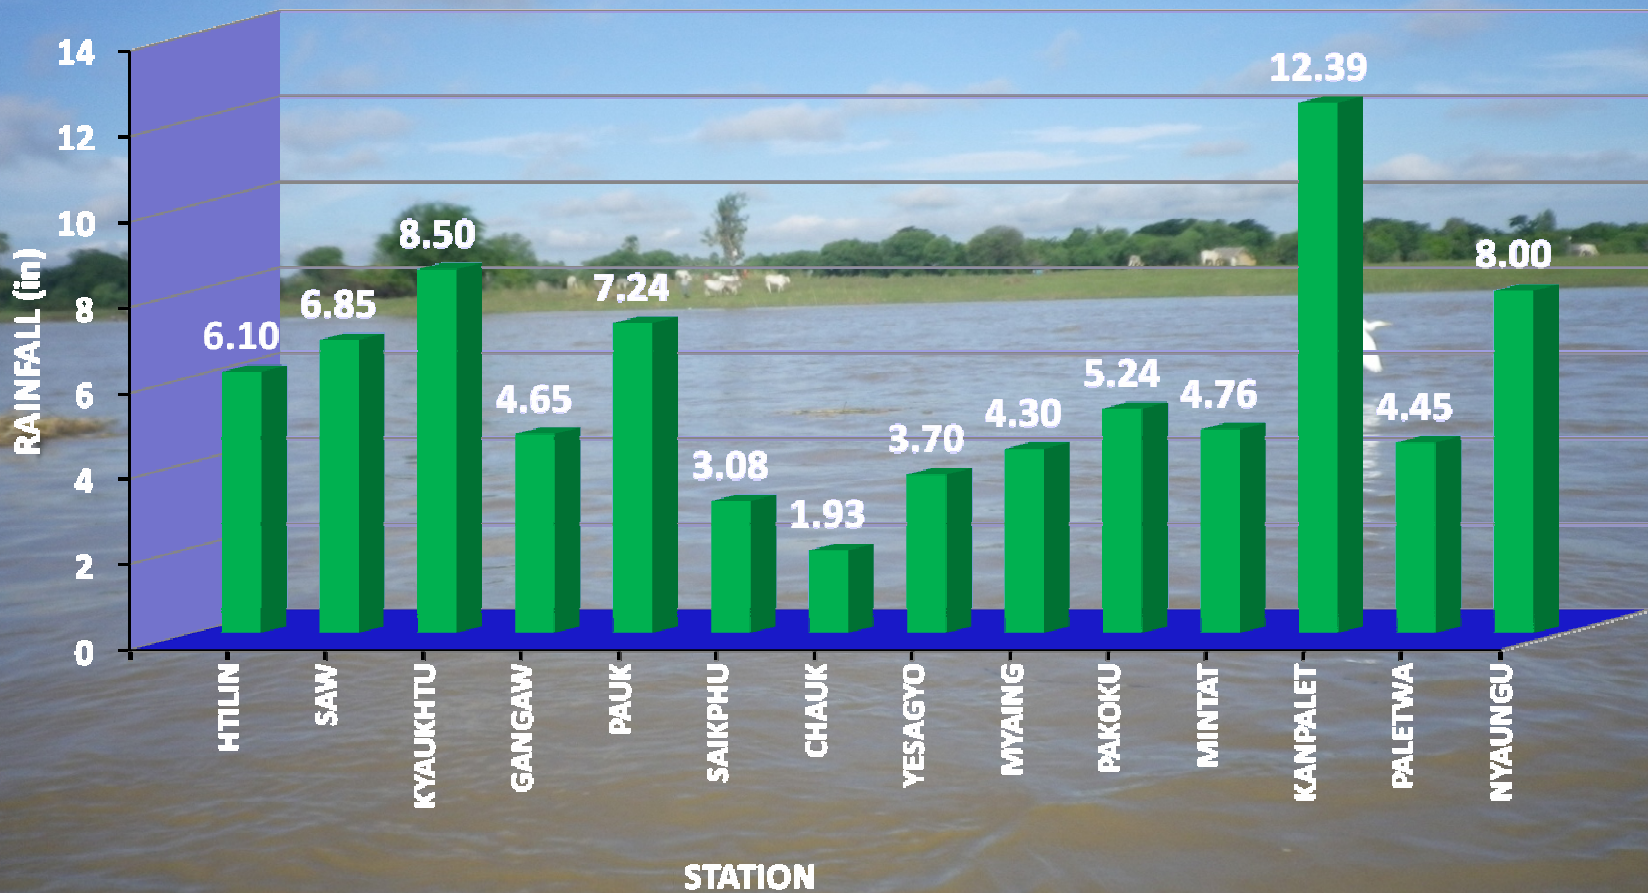
*MAXIMUM RAINFALL OF THE STATIONS IN THE SHWECHAUNG  
CATCHMENT AREA  
DURING THE PERIOD OF FLASH FLOOD OCCURRANCE (20-10-2011)*

■ Rainfall(in)

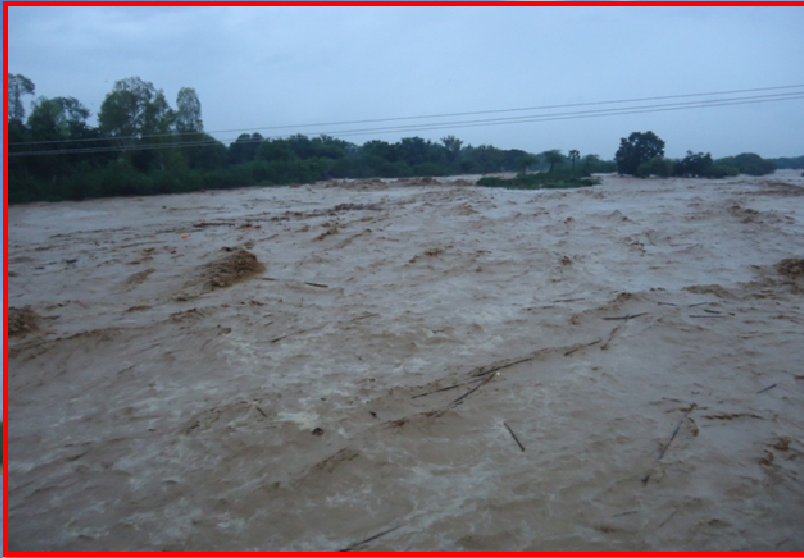
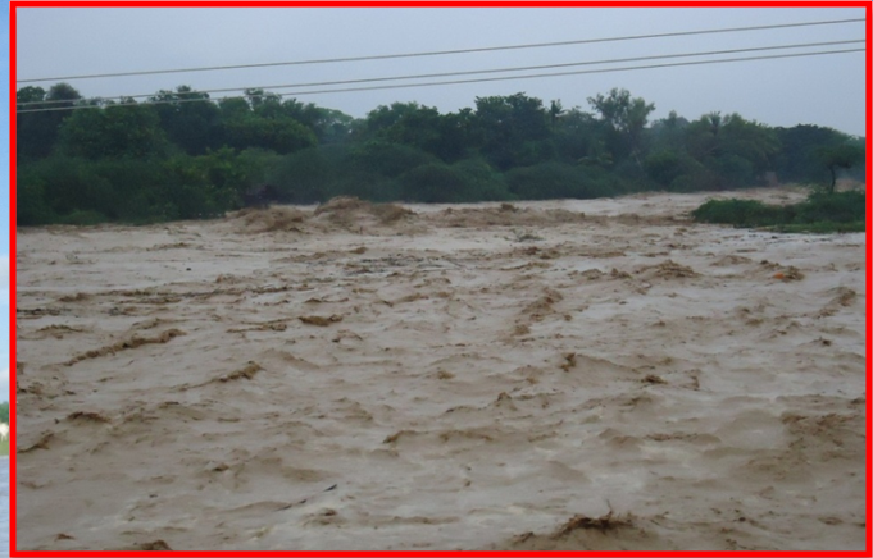
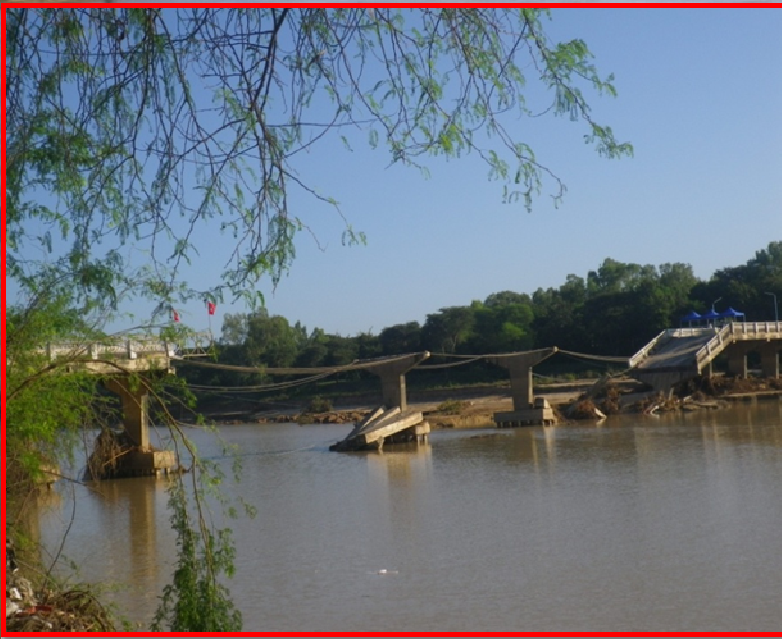
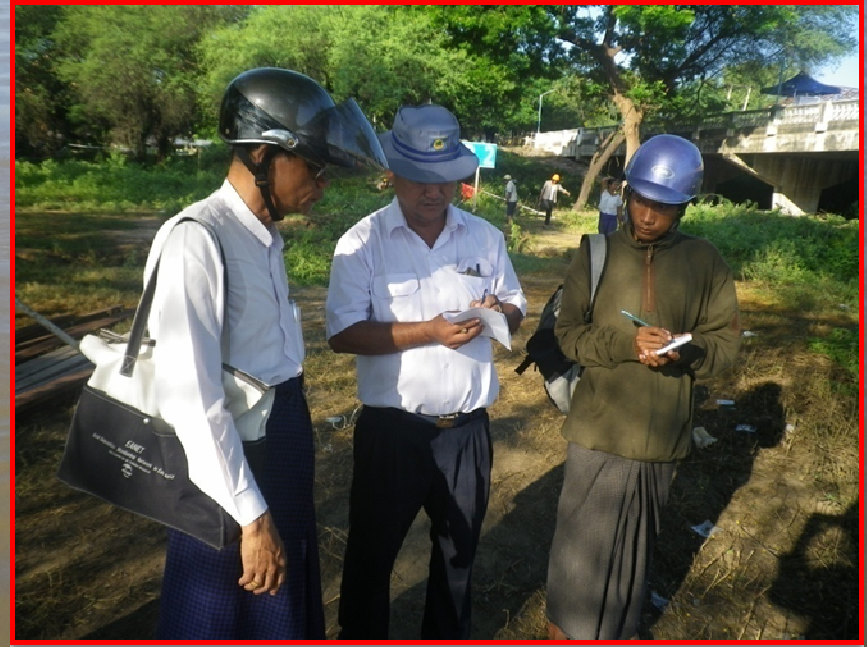
# *Shwechaung Flash Flood at Pakokku (20-10-2011)*

The causes of Shwechaung flash flood on 20<sup>th</sup> October 2011 are as following:-

- The effect of heavy rainfall
- Soil erosion
- Topography
- Channel storage capacity and
- Bank erosion

• No. of affected village-tract	=	217
• No. of Kwin	=	365
• No. of farmers	=	6805
• Acre affected	=	8376
• Acre destroyed	=	3253
– Flood	=	1840
– Sand covered	=	752
– Eroded	=	661

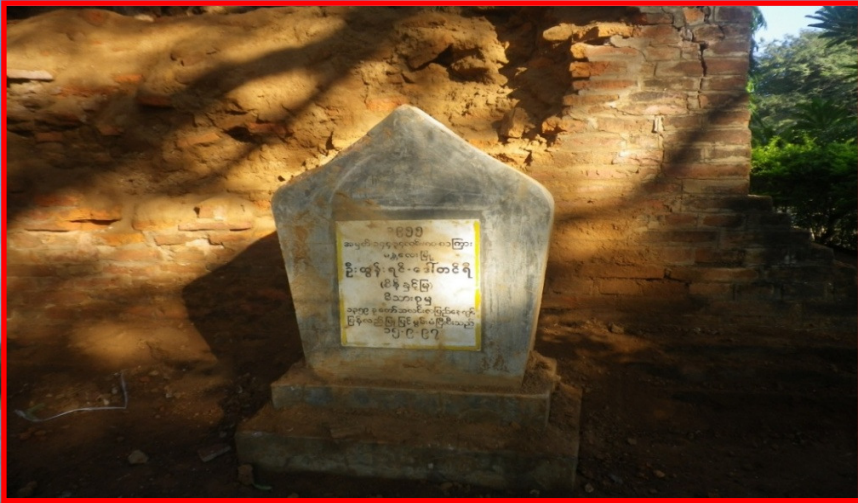
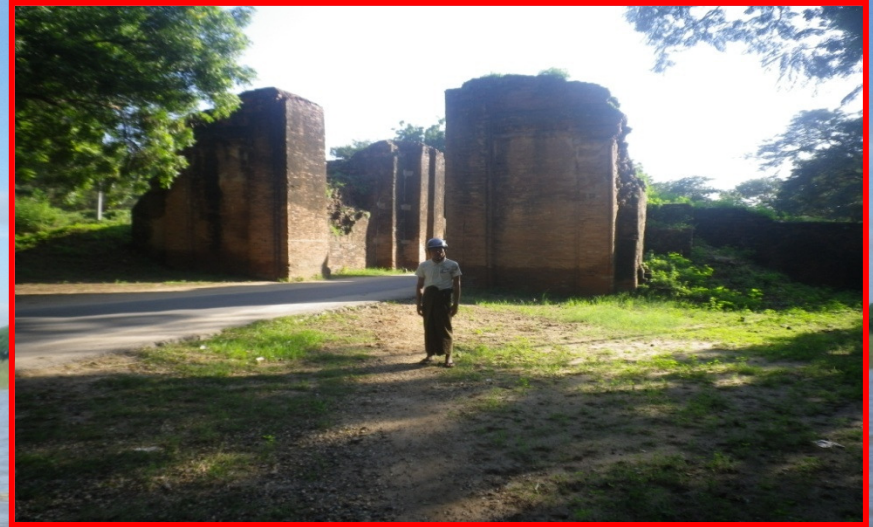
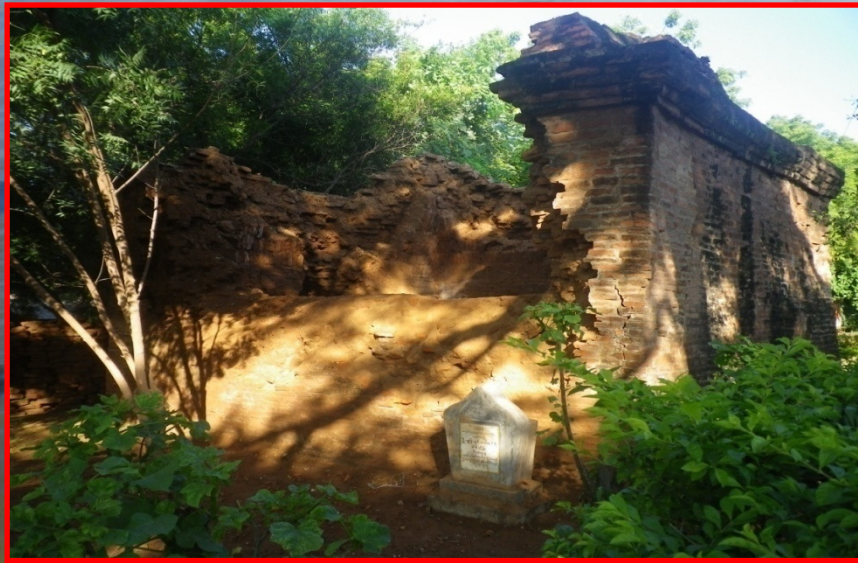
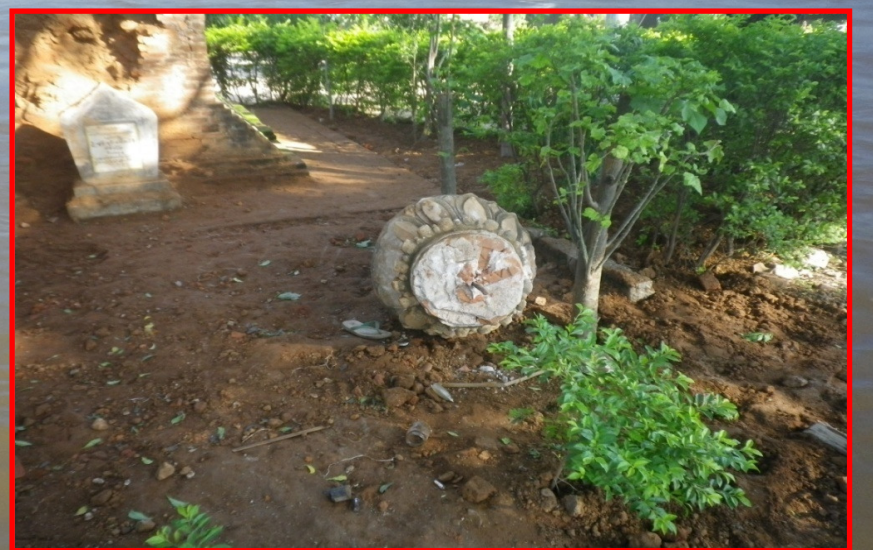
*Damages caused by heavy Rainfall at Nyaung U and Bagan (20.10.2011)*
